Condition assessment of a Johannesburg skyscraper

Abstract. This paper presents a condition assessment conducted on a Johannesburg skyscraper. It had become apparent that concrete spalling occurred in areas of the top 11m of the Southern and Western facades of the reinforced concrete skyscraper constructed in the 1970's. However, the extent of the problem was unknown. The only information available were two photographs showing spalled concrete and severely corroded reinforcement bars. Some literature search pertaining to the structure was conducted after which, visual inspection and mapping of spalled areas and cracks were conducted. This was followed by a cover meter survey, a half-cell potential survey, and the removal of 20 (twenty) cores for laboratory testing. It was found that the typical problems associated with carbonation and insufficient cover resulted in the corrosion of reinforcement which then led to the spalling observed.

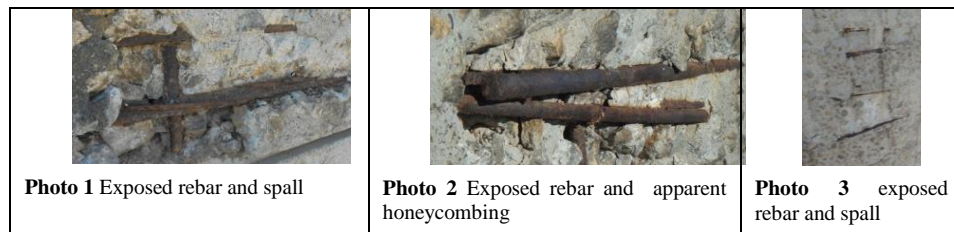
Photographic surveys, mapping of cracks wider than 0.3mm and mapping of areas of spalling were conducted. The surveys provided strong evidence that the problems were localized. **Photo 1** to **Photo 3** shows some of the problematic areas.

Site survey determined that the spalling was localized, in areas of very low cover. Carbonation attack was the mechanism identified to have caused corrosion of the reinforcement, which then resulted in spalling. In the 40 MPa concrete, carbonation had progressed to about 19.4 mm over the 40 years of the structure's lifetime. However, the cover in the façade varied significantly to the extent that the very low cover areas were severely affected by corrosion.

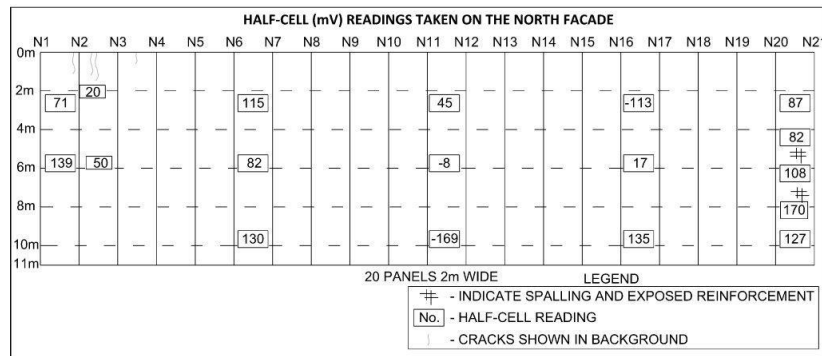
Figure 2. Half-cell potential measurements taken on the South facade

Half-cell potential measurements were conducted to assess the likely presence of corrosion activity, whether hidden or visible. Typically, readings of less than -350mV imply a 95% probability of corrosion occurring, whilst readings higher than -200 mV suggest less than 5% probability of any presence of corrosion[1-3]. Half-cell readings that were obtained, varied between -170mV to +180mV. The results indicated that no corrosion activity was occurring at the locations where measurements were taken[4]. **Photo 8** shows a technician performing the half-cell tests while the data was being captured at a safe location, as in **Photo 9**.

Half-cell readings were taken at random locations and also near cracks. **Figure 2** indicates the locations and readings of half-cell measurements taken on the South facade.
