# Statistical analysis of concrete cover in new highway bridges

## **Abstract.**

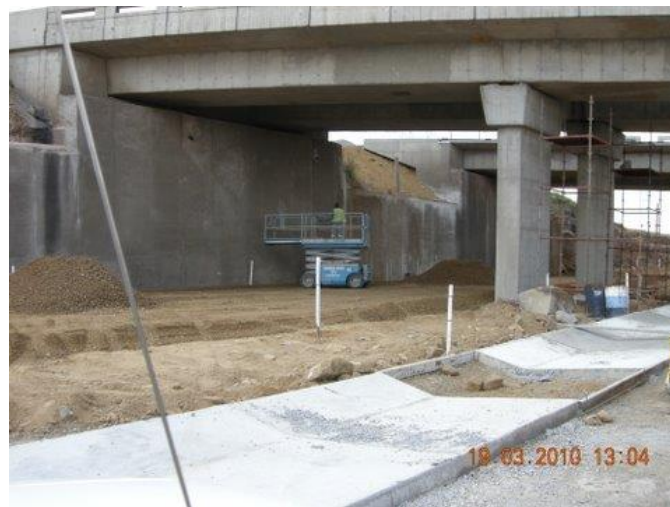
**Figure 2.** A newly completed highway bridge structure

Cover survey on the bridges was conducted upon completion of the whole bridge superstructure construction. The survey was conducted based on the different elements, consisting of the deck, piers and abutments. This was done in such a way as to survey the whole bridge structure. Each element was divided into a grid pattern that was used to select points of measurements. A view of one of the bridges can be seen Figure 2.

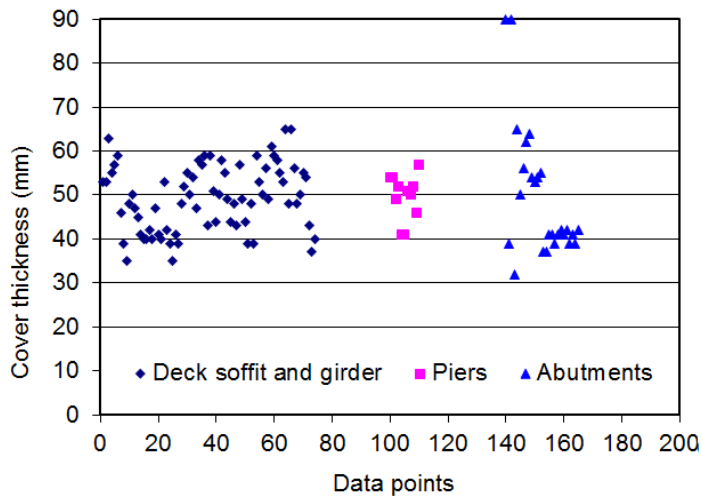
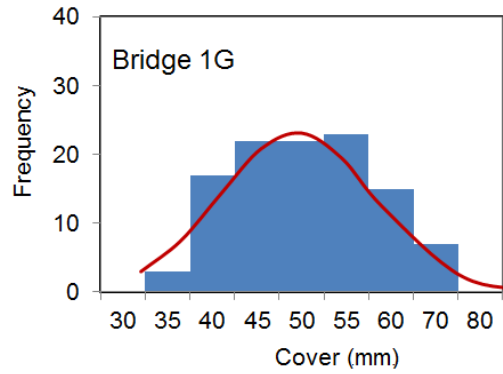
**Figure 2.** Scatter plot and histogram of cover for bridge 1G

sections may have very low cover while others may show excessively high cover. The scatter in data gives an indication of the uniformity of cover thickness as built. For this purpose, scatter diagrams of results have been plotted in Figures 2, 3, and 4 for the bridges 1G, 2R and 3C respectively. It is evident, for example, in Figures 3 and 4 that the deck soffit exhibit cover thickness values as low as 30 mm while others were as high as 67 mm. Similar scatter can be seen in Figure 2 data for the abutments.

Histograms shown in Figures 2, 3 and 4 show data which is characterised by a normal distribution curve, indicating normalcy of the data generation process. The histograms for bridge 1G gave a much broader peak than the other two bridges 2R and 3C while the range of cover thickness remained similar for all the bridges. Table 1 also gives the standard deviation for the various elements and the overall coefficient of variation (CV) of the measurements. Of all the structural elements, only the bridge decks showed a consistent standard deviation of about 7.0. The piers had a relatively low standard deviation of 5.0 for bridges 1G and 3C but for some reason, the corresponding standard deviation was very high for bridge 2R. Of all the elements, abutments gave the highest standard deviation, ranging from 10 to 11 compared to 5 to 7 for the deck and pier. This observation may be related to higher quality control measures being applied to the deck and piers, compared to abutments, as the former elements are more crucial for load bearing than the latter. In all the three bridges, however, the CV is consistent, falling in the range of 18 to 21%.

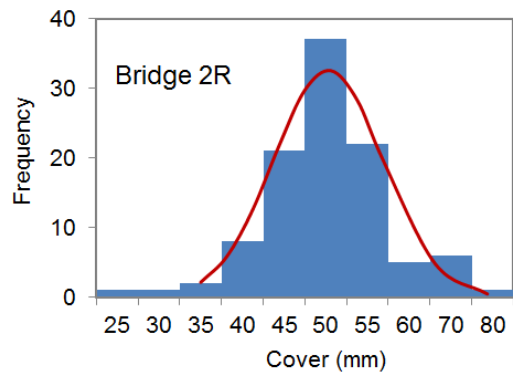
**Figure 3.** Scatter plot and histogram of cover for bridge 2R
