# Treatment of a stochastic service life prediction model to an evaluation of a distressed two-story RC building

**ABSTRACT:** A service life prediction model is applied to a distressed two-storey building structure in Liberia for purposes of examining the model performance. The structure was estimated to be a 30 to 40 year old reinforced concrete (RC) structure due to be renovated for use as a residential and office building. Condition survey showed carbonation – induced reinforcement corrosion among structural members. The stochastic parameters used in the model analysis were taken from previous work (Ekolu, 2010). The stochastic model is environmentally sensitive and data from the condition survey was used to assess the model outputs. Basing on the model, the building's service life is estimated to have been in the range of 20 to 30 years. It is found that the model makes generally reasonable prediction of the current condition of the building. But this work also identifies some problems with the model that require research for performance improvement and imbue ment of robustness for future use in service life estimation for concrete structures.

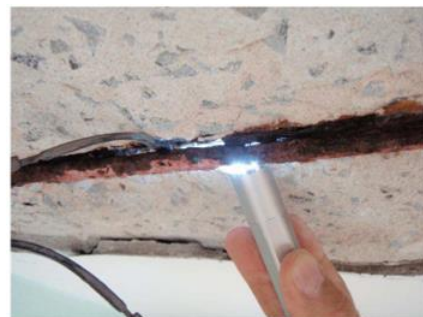
- Inspection of exposed rebars provided important information on the bar type and size (diameter), bar spacing, cover depth, and the severity of bar corrosion (see Figure 3).

Figure 3 Severely corroded bar, completely debonded from concrete

- Nearly all the reinforcement bars that were exposed for inspection were found to have corroded. Some of the severely corroded bars were completely de-bonded from the concrete with flakes of rust products coming off easily upon scraping with a knife. It was estimated that the severely corroded bars had lost as much as 30 to 50% of their cross-sectional areas.

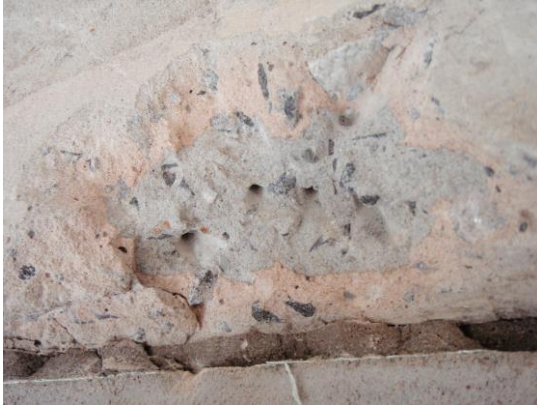
While it was evident from site inspection that the concrete had severely carbonated, information supplied from the site indicated that certain sections of the 30 to 40 year old building exhibited presence of colour changes between the outer concrete layer and interior concrete of structural members. Colour modification from the normal gray to brownish orange colour was evident from the surface to a certain depth of the concrete cover as seen in the fractured concrete shown in Figure 4. The observed colour change was quite puzzling as it is uncommon that such colour modifications could occur naturally due to carbonation. Concretes typically do not exhibit colour changes upon carbonation. It was of interest therefore to determine the mechanism associated with the colour change.

Figure 4. Field evidence of colour change (to orange) in the outer layer of concrete compared to the original gray colour seen in the interior concrete

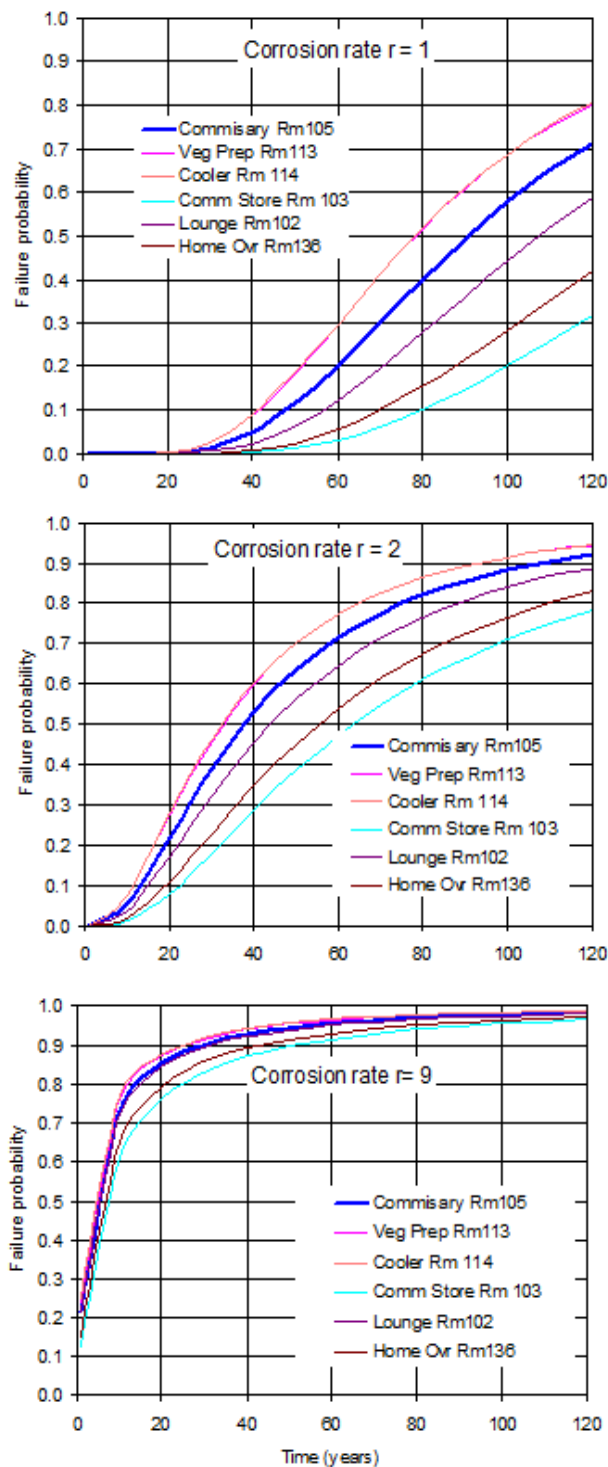
The full model with both components was also used to assess the influence of corrosion rate and bar size. In applying the service life prediction model, it was found that the second term was dominant and controlling, the two most sensitive variables being the corrosion rate and the diameter of the steel bar. Basing on experimental data, Tutti, 1982 suggested that the corrosion rate in carbonated concrete structures sheltered from rain can be evaluated at 90% relative humidity (RH) and proposed,  $r = 12 \mu\text{m}/\text{year}$  for 90%RH and  $r = 1 \mu\text{m}/\text{year}$  for 80%RH. The carbonation rates suggested for European cities range from 2.5 to 9  $\mu\text{m}/\text{year}$  for concrete sheltered from rain (RILEM, 1996). Figure 8 shows the significant influence of change in corrosion rate on service life prediction for a fixed bar diameter of 12 mm. Clearly, the distribution curves are extremely sensitive to the changes in corrosion rate. For example, an increase of corrosion rate from 1 to 2  $\mu\text{m}/\text{year}$  reduces services life estimation by more than one-half, while rates as high as 9  $\mu\text{m}/\text{year}$  do not seem to give meaningful estimations. Similarly, the bar diameter have a marked influence on the estimations as shown in Figure 9. Increasing the bar size from 12 mm to 16 mm reduces service life estimation by about 10 years.

Figure 8 Probability distribution functions for varied corrosion rates and fixed bar diameter of 12 mm

The high sensitivity of the service life predictions of the model to corrosion rate and bar sizes raises concerns since slight changes can greatly alter results. The problem is worse in the case of corrosion rates, which are generally difficult to establish for anyone environmental location. In African regions, there are no established or known corrosion rates that may be used in applications such as service life models. For the building structure examined in this paper, the question of the correct rate for use in the model analysis cannot be answered at this point and further research is needed. The corrosion rate of 1  $\mu\text{m}/\text{year}$  appears to be too low while 9  $\mu\text{m}/\text{year}$  is too high. Intermediate values between 2 to 4  $\mu\text{m}/\text{year}$  appear to be appropriate. From the observed condition of the structure, the 10% failure probability has certainly been exceeded. If a 50% failure probability is assumed, the corrosion rate of 2  $\mu\text{m}/\text{year}$  places the service life estimation of the structure within the range of 30 to 50 years. The survey of the structure was conducted in 2010 for a building estimated to have been constructed in the 1970's. Comparing the service life predictions and actual field observations, it can be surmised that the model outputs are meaningful.

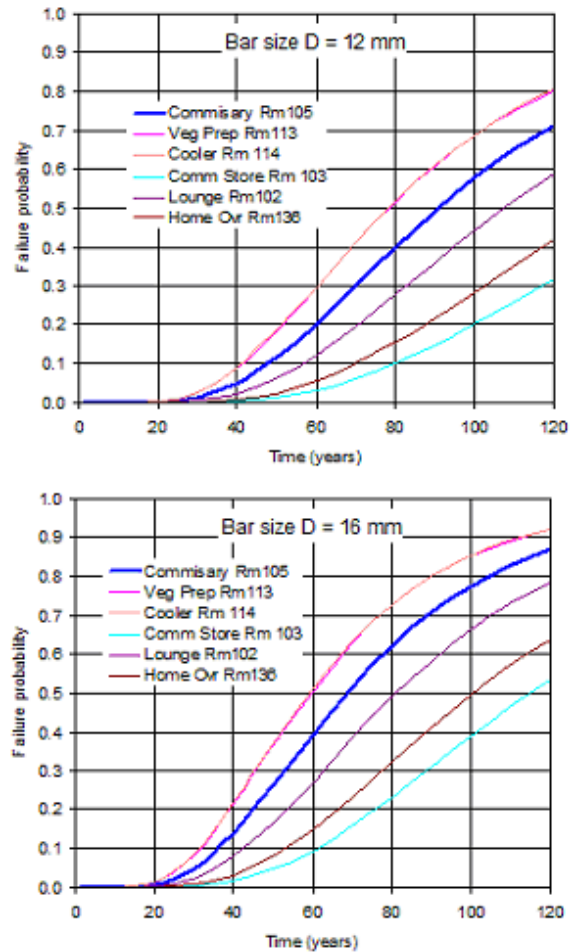
Figure 9 Probability distribution functions for a fixed corrosion rate  $r = 1$  and varied bar diameters
