Treatment of a stochastic service life prediction model to an evaluation of a distressed two-story RC building

ABSTRACT: A service life prediction model is applied to a distressed two-storey building structure in Liberia for purposes of examining the model performance. The structure was estimated to be a 30 to 40 year old reinforced concrete (RC) structure due to be renovated for use as a residential and office building. Condition survey showed carbonation – induced reinforcement corrosion among structural members. The stochastic parameters used in the model analysis were taken from previous work (Ekolu, 2010). The stochastic model is environmentally sensitive and data from the condition survey was used to assess the model outputs. Basing on the model, the building's service life is estimated to have been in the range of 20 to 30 years. It is found that the model makes generally reasonable prediction of the current condition of the building. But this work also identifies some problems with the model that require research for performance improvement and imbue ment of robustness for future use in service life estimation for concrete structures.

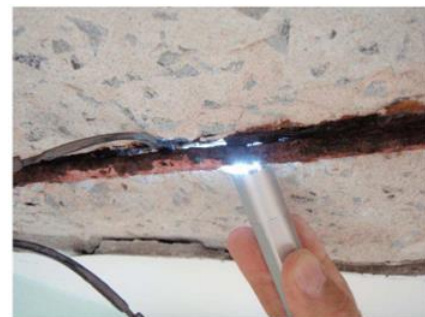
- Inspection of exposed rebars provided important information on the bar type and size (diameter), bar spacing, cover depth, and the severity of bar corrosion (see Figure 3).

Figure 3 Severely corroded bar, completely debonded from concrete

- Nearly all the reinforcement bars that were exposed for inspection were found to have corroded. Some of the severely corroded bars were completely de-bonded from the concrete with flakes of rust products coming off easily upon scraping with a knife. It was estimated that the severely corroded bars had lost as much as 30 to 50% of their cross-sectional areas.

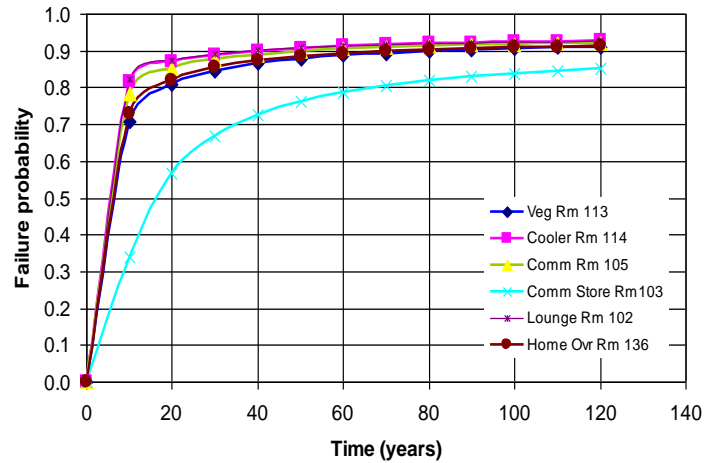
depassivation of steel was taken as the limiting criteria defining the end of service life. Results of this analysis are shown in Figure 7 for the seven sites investigated in the RC building. It can be seen that carbonation of the cover thickness progressed quite rapidly in the early ages of the structure. This is consistent with the structurally low strength, low quality concrete. The model also predicts with 80% probability that the full cover thickness of the structural members carbonated within the first 20 years of the structure's life. The model results agree with field observations from onsite inspection and survey showing that the cover thickness of a majority of structural members had carbonated, reaching and in some cases going past the level of steel reinforcement (see Section 3). While the results of model prediction generally corroborate field observations, the absence of accurate information on the exact age of the building makes it difficult to precisely relate model predictions to the observed service life condition of the structure.

Figure 7 Probability distribution function for carbonation of the structural members
