Disintegration of concrete construction induced by acid mine drainage attack

In this paper, microanalytical investigation was conducted on disintegrated field concrete that had been used to construct a weir within a coal mine in South Africa. The concrete was in contact with polluted mine water, commonly referred to as *acid mine drainage* (AMD). Accordingly, the concrete weir had been exposed to dynamic conditions associated with flowing AMD. Investigations were conducted by optical microscopy (OM), scanning electron microscopy (SEM) equipped with energy dispersive X-ray spectrometry (EDX), and X-ray diffraction (XRD). The field concrete samples examined consisted of soft broken concrete chunks and whitish powdery substance that had crystallized and formed a surface coating on the widely cracked locations of the deteriorated concrete. No evidence of sulphate attack or pyrite oxidation was found in the investigation; acid attack mechanism was diagnosed.

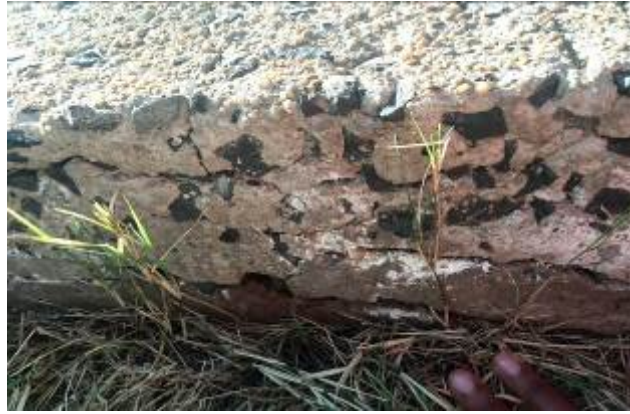
Figure 1 Disintegrated concrete weir at a site of acid mine drainage decant (Azene & Ekolu 2012)

While conducting field survey in an abandoned coal mine, the authors observed severe exfoliation of a concrete weir that was in contact with AMD (Figure 1). A detailed

The samples used in this investigation were the AMD water and the deteriorated concrete specimens collected from the field site. As described in Azene & Ekolu (2012), severe exfoliation had been exhibited in concrete above the water line, showing:

- A line of disintegration separating concrete above the water line from the foundation (Figure 1)
- Map cracking pattern, seemingly oriented longitudinally along the length of the wall lining. The deterioration and cracking occurred across the full thickness of the 250 mm concrete weir (Figure 1)
- Swelling and spalling of the concrete leading to falling out of disintegrated chunks of concrete
- Depositions of powdery salt crystals on the concrete surface. The surface depositions exhibited a white-yellowish discoloration
- Erosion of cement past matrix leaving protruding aggregates

In Figure 5, a map cracking pattern is evident but also present are oriented parallel cracks, especially seen in Figure 5a. This combination of map and parallel microcracks is consistent with the cracking patterns observed during physical examination of the exfoliated concrete weir, as shown in Figure 1.

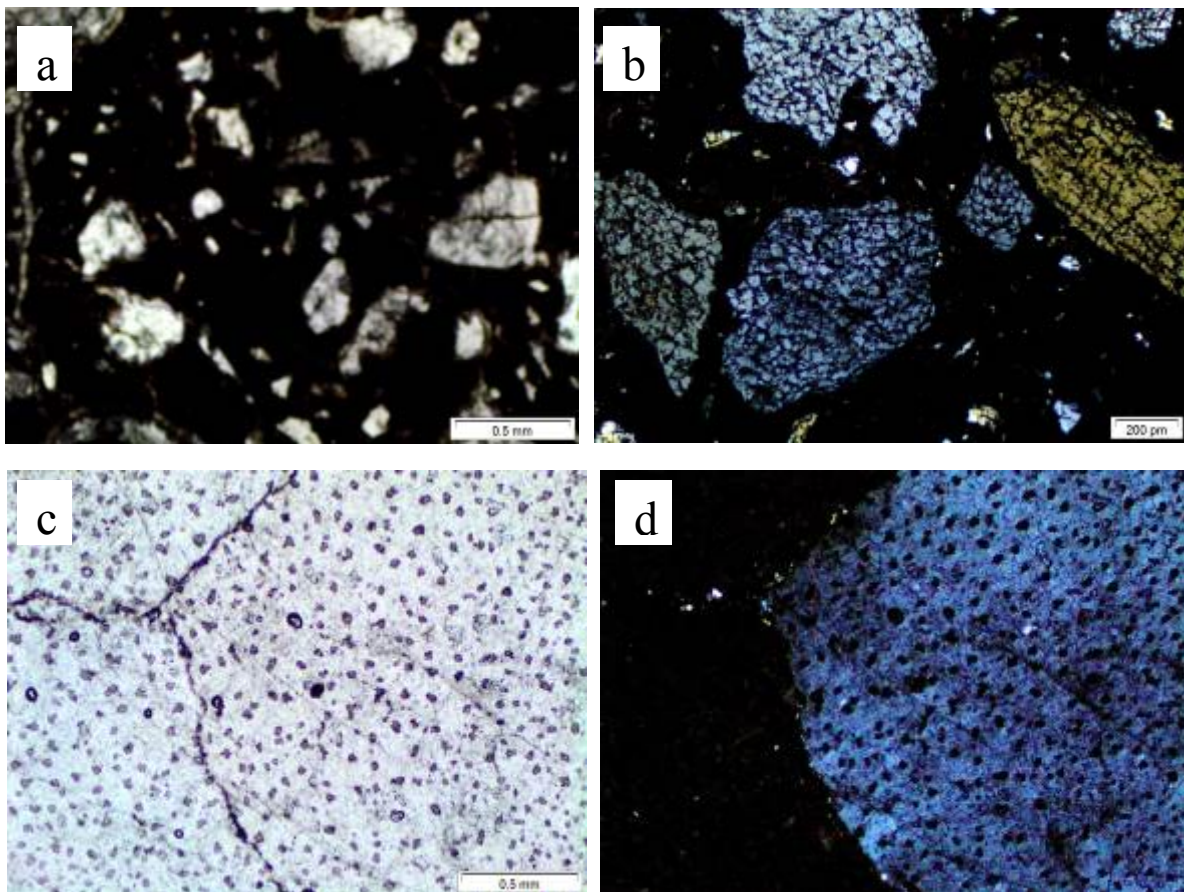
Figure 2 Photomicrographs of thin sections showing aggregate types and features under plane polarized light: (a) predominant presence of quartz particles, (b) severely weathered quartz particles, (c) fractured aggregate devoid of infilling, (d) same as (c) but viewed at higher magnification.

Petrographic examination revealed the presence of predominantly quartz aggregates and opaque minerals, as the main types of aggregates used in the concrete mixtures. Figure 2a illustrates the typical quartz aggregates identified in the damaged concretes. Evidently the aggregates are circumvented by a network of cracks, as discussed later. Figure 2b gives a closer view of the aggregate surface features. It can be seen that the quartz particles are severely weathered, indicating a likely leaching away of surface material including cement paste and the associated phases. Leaching is a highly likely possibility given the exposure of the concrete to flowing AMD which then caused erosion of leachable phases both from the

cement matrix and aggregate surface. There was also an observation of fractured quartz aggregate particles as seen in Figure 2c. However, no infilling of the fracture was evident, indicating this damage to be of mechanical nature. A close up of the fractured particle, shown in Figure 2d shows a good bond between the particle and the cement paste but there appears to be concentration of unreacted pyrites lining along the aggregate rim and further into an opaque mineral aggregate. In Figure 3a, sulphate bearing minerals, most likely pyrite and pyrrhotite, can be seen distributed throughout the opaque mineral aggregate. This feature can be seen further at a higher magnification given in Figure 3b, clearly showing a widely disseminated (pale yellow) pyrite within the opaque aggregate particle.

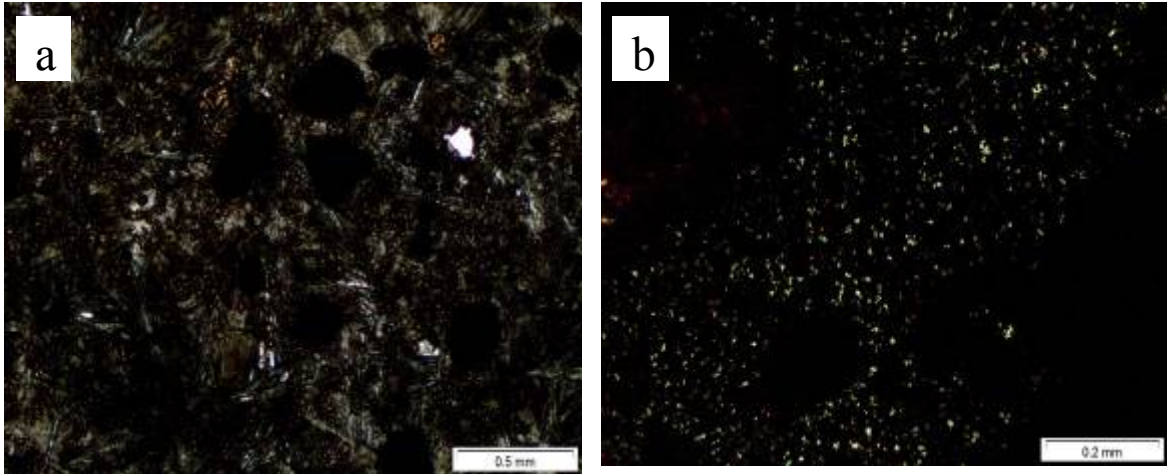
Figure 3 Photomicrographs of thin sections showing sulphate bearing minerals under plane polarized light: (a) opaque minerals, (b) a close up of (a) highlighting disseminated pyrites in an opaque particle under cross polarized light

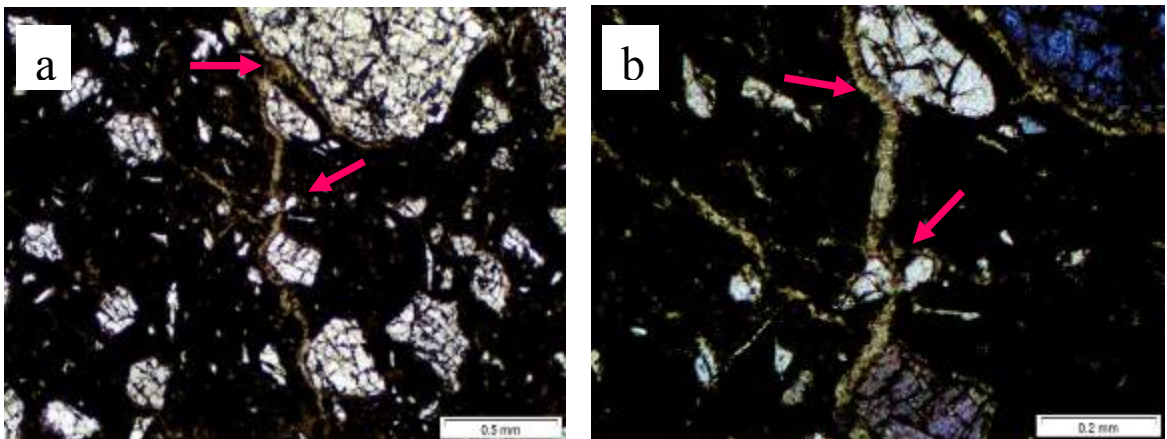
Figure 4 Photomicrographs of thin sections showing: (a) microcracks and infilling under plane polarized light, (b) a close up of (a) highlighting microcracking running through or over a sutured quartz particle in cross-polarized light

Thin sections were also examined for the presence of microcracks and expansive phases. Figure 4 gives microscopic images of microcracking observed in thin sections of the deteriorated concrete samples. In Figure 4(a) and (b), microcracks can be seen circumventing the aggregate particles, undertaking to follow aggregate rims, which in healthy concrete, is a typically weak interfacial transition zone (ITZ) comprising large depositions of calcium hydroxide relative to the CH present in the mortar matrix (Scrivener & Pratt 1994, Ollivier et al 1995, Harutyunyan et al 2000). The interconnected cracks run directly through the paste matrix, forming a multidirectional crack network. All the microcracks along the ITZ and paste matrix, are infilled with a mineral phase, later identified through SEM analysis, to be gypsum. It may be emphasized that this observation was not an isolated case but rather a characteristic feature. The visibly fibrous gypsum infilling, perpendicularly oriented to the crack walls indicates exertion of expansive pressure during the phase growth. In Figure 4(b), an infilled crack can be seen running through a severely weathered and sutured quartz particle as well as around its rim. This appears to be an isolated case where the particle may have

been fractured mechanically or due to weathering. In this case, the microcrack and its gypsum infilling opportunistically developed its path through the fractured particle. There is no evidence within or at the aggregate rims suggesting that the particle may be involved in an expansive reaction.

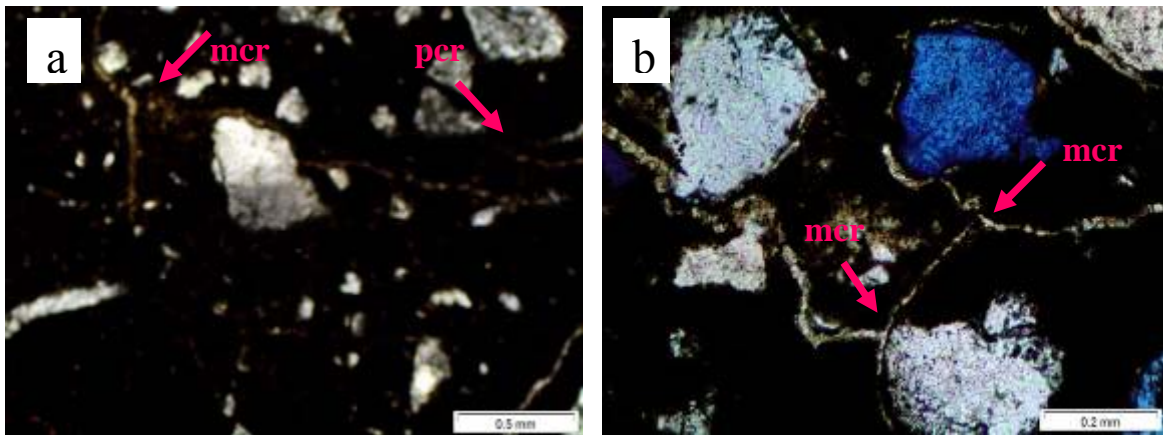
Figure 5 Photomicrographs of thin sections showing: (a) map patterns and parallel microcracks viewed under plane polarized light, (b) a close up highlighting multidirectional map cracking and infilling of cracks under cross polarized light: mcr – map cracks, pcr-parallel cracks

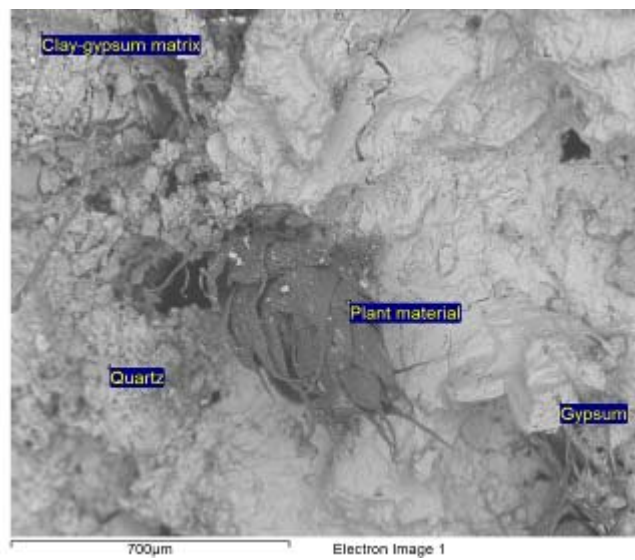
Figure 6a. SEM image of the deteriorated concrete sample

Figure 6a gives a backscattered electron image of deteriorated concrete taken from the field site. The main mineral phase seen in the micrograph is gypsum. Also seen in the image is contamination associated with clay and plant material intermixtures. The identified quartz is a phase from the sand used in the concrete, confirming observations made by petrographic examination. The dominant presence of gypsum in the pore structure is unusual in normal concrete and represents a likely attack process. It is also evident that gypsum forms the major groundmass product of the micrograph. Figure 6b shows the associated EDX spectra for the various phases identified. It can be seen (Figure 6b) that the EDX spectra for gypsum is mainly calcium (Ca), sulphur (S) and oxygen (O) which form the main elemental composition of the mineral phase. Similarly, fine aggregate of quartz consists predominantly of silica (SiO_2). The other spectra are for the clay and plant contaminants found intermixed in the concrete. Further SEM analysis using another sample taken from the deteriorated field concrete is given in Figure 7, also showing the electron micrograph and the associated EDX spectra of the major phases observed. Again, the electron micrograph shows an infilling of gypsum as the dominant product in the groundmass of the matrix. The morphology of the gypsum consists of crumbled, compacted crystals being perhaps an indication of the existence of expansive pressures exerted against the crack walls. No other sulphate bearing phases such as ettringite or thaumasite were observed. Also not observed were any rust product phases such as

goethite (FeO(OH)), Ferrihydrite (Fe(OH)₃) or hematite ($\frac{1}{2}$ Fe₂O₃), which rules out possible involvement of pyrite oxidation in the attack.

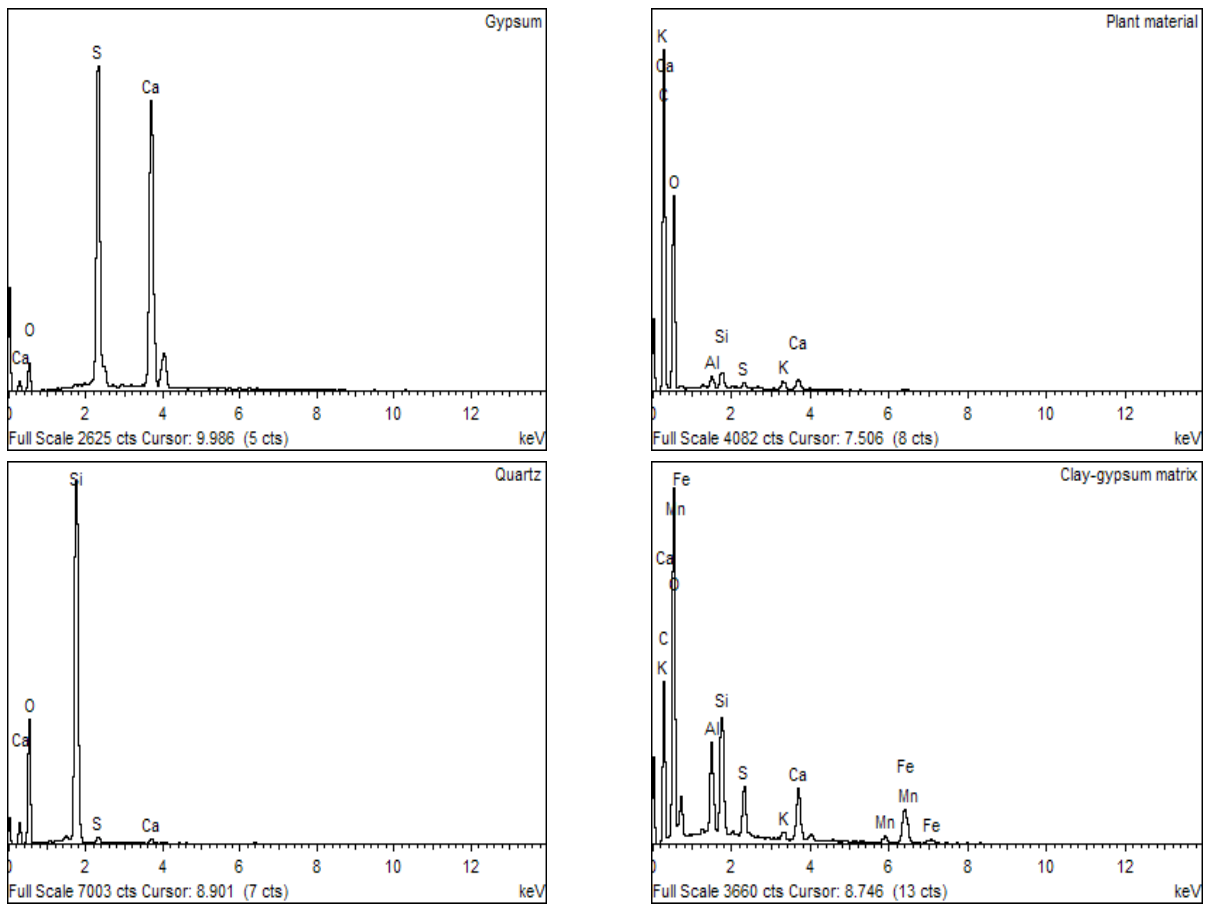
Figure 6b. EDS spectra of various phases labeled in Figure 6a

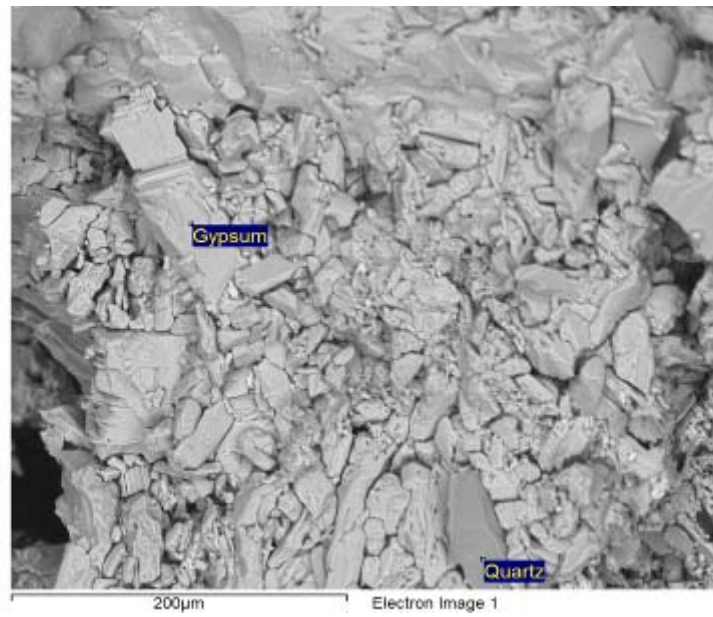
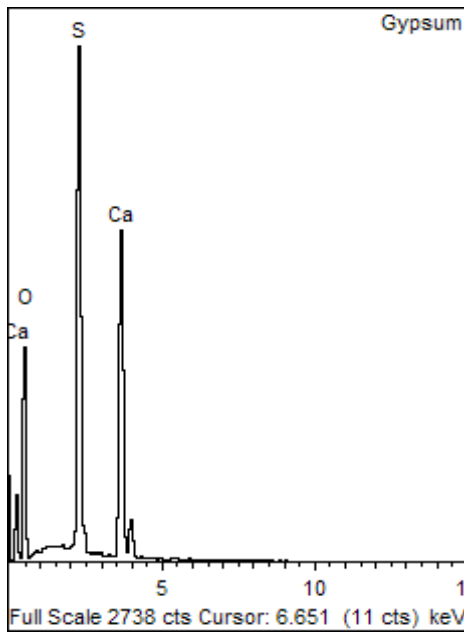
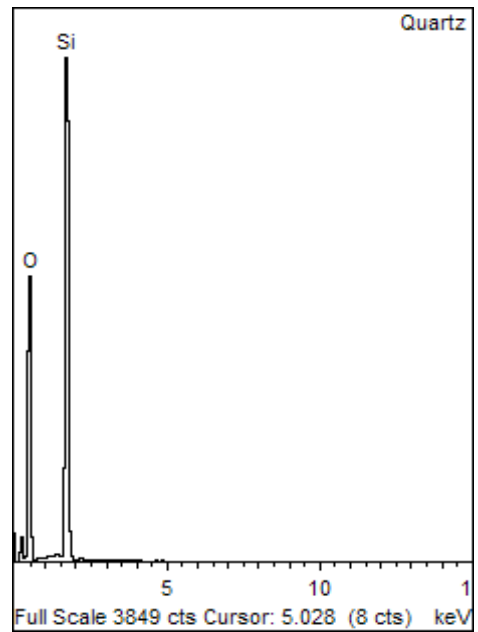
Figure 7 SEM image and EDS spectra of the deteriorated concrete

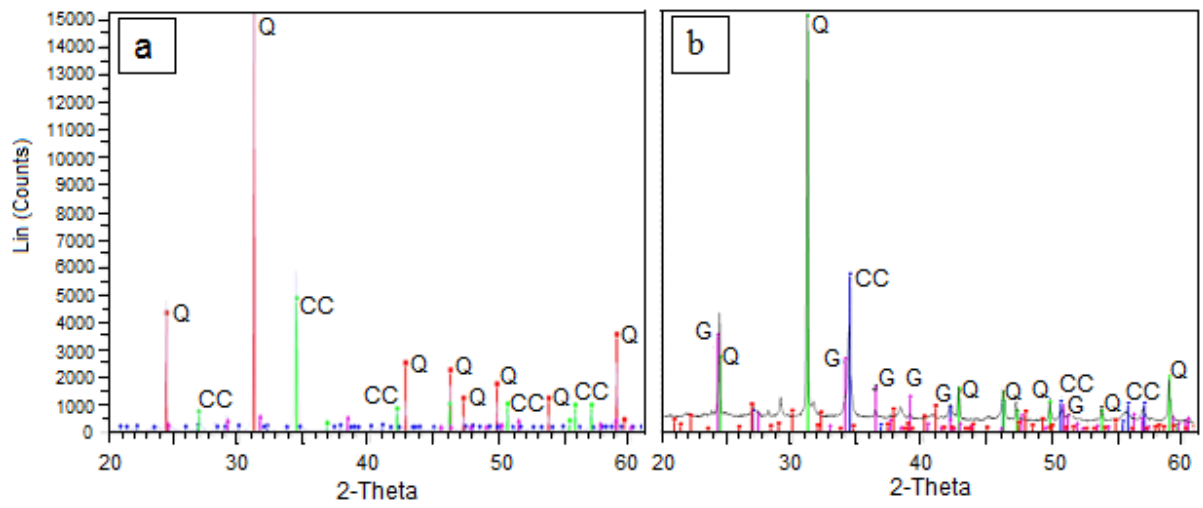
Figure 8 XRD pattern of disintegrated field concrete: Q - quartz, G - gypsum, CC - calcite

Samples broken-off from the mortar matrix of disintegrated concrete were dried and ground with mortar and pestle into fine powder passing 90 µm sieve. The powder samples were back-loaded into the sample holders and analysed. The XRD analysis determined the final reaction products and phases predominantly present in the cementitious system. Figure 8 shows the XRD patterns for the disintegrated concrete samples. The samples comprised phases that were identified to be quartz, gypsum and calcite. In both spectra shown, it is interesting to note that no portlandite was found among the phases identified. This implies that this phase is likely to have undergone conversion to calcite under carbonation, and/or to gypsum, the latter being the reaction product of CH with AMD. Furthermore, ettringite which is an opportunistic phase that is usually present in concrete, was generally not found. These changes in the matrix products of concrete are important indications of the conversion reactions that could have led to the observed disintegration of the concrete. Again, no trace of rust products such as goethite, ferrihydrite or hematite, were detected which also excludes the possible presence of pyrite oxidation as participant in attacking the cementitious system.

XRD analysis, there was no evidence of CH being present in the concrete. In a normal healthy concrete matrix, CH is plentiful and is responsible for the high alkalinity of concrete, usually with $\text{pH} \geq 12.6$.
