FACTORS THAT CAUSE ENGINE FAILUIRES ON DIESEL LOCOMOTIVES

A.R Mayoyo, South Africa, 2015

Department of Engineering and built environment University of Johannesburg, South Africa aobakwe.mayoyo@yahoo.com

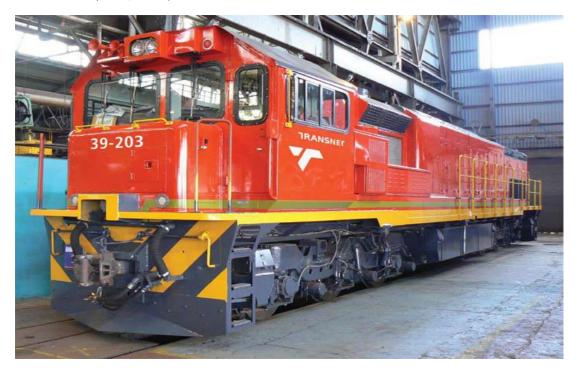
Figure 1: Diesel locomotive (Transnet, 2014).

Figure 1 shows the diesel locomotive, and Figure 2 illustrates the engine of the diesel locomotive on which the research will be based. The diesel engine in the locomotive drives the main alternator to generate electricity, which powers the traction motor to make the wheels turn (Park, 2012).

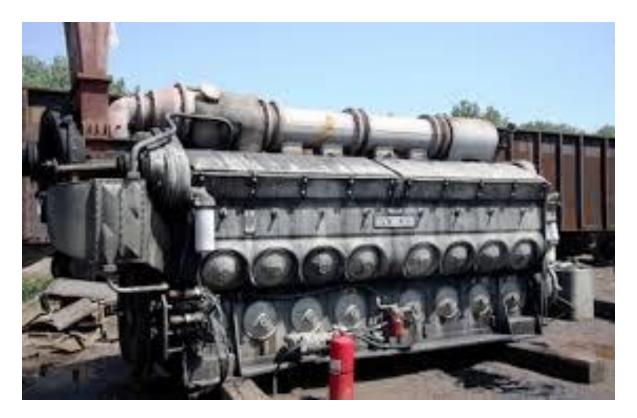
Figure 2: Engine of diesel locomotive (39 200 class) (Transnet, 2014)

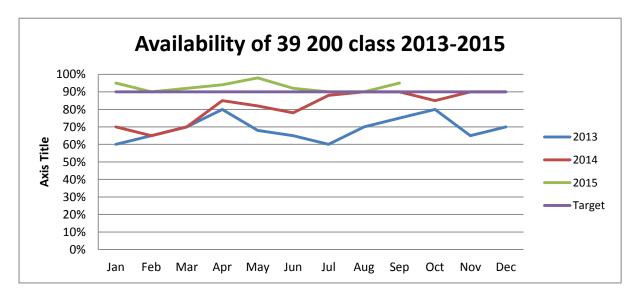
Figure 3: The availability graph of 39 200 (2013-2015) (Transnet, 2014)

The results were based on the 39 200 class diesel locomotives that operate between Thabazimbi and Lephalale only. Availability target is 90% per day that is set by the company, taking in consideration the planned maintenance. Transnet had poor availability from 2013 to 2014 according to Figure 3. They introduced Pareto analysis by looking at the highest failures that cost train delays. The availability started to pick up early 2015 and the data was collected until September 2015. The maintenance and reliability engineers found that the depot was using wrong material on the 39 200 class locomotive because they artisans were not aware of the difference between chrome and millmille cylinders. Figure 4 shows the highest failures on the diesel locomotive.

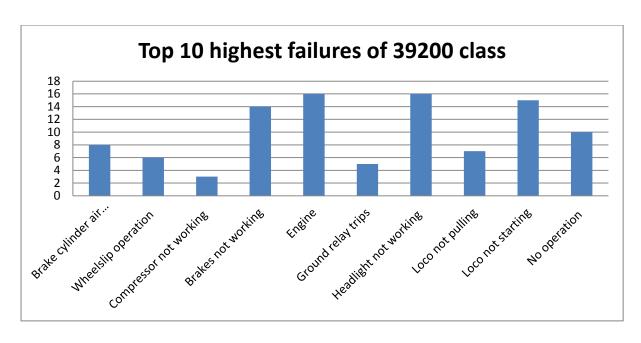
Figure 4: Top 10 highest failures of 39 200 class (Transnet, 2014)

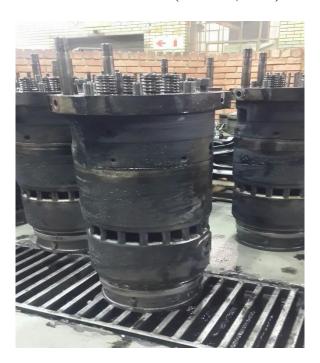
Figure 5: Diesel engine cylinder

Figure 5, illustrate the wrong type cylinder that was used on the 39 200 diesel locomotive. The millmille and chrome look similar but two cylinders are engineered with different material. It was found that it caused a lot of engine failures on the diesel engine locomotives. Some locomotives failed after scheduled maintenance that affected locomotive availability.

The 39 200 class diesel failed due to wrong type of cylinders that were used on the engine. It was something related to maintenance, maybe the specification was not clear to the logistic department. China and Ukraine had the same problem, whereby the failures were caused by maintenance. The maintenance department did not follow the maintenance plan accordingly and some locomotives in Ukraine were too old, they were changing components due to the condition. It is very important to specify which components and brand should be used especially on engines to make sure they are reliable. These failures could have been avoided if it was clear, to all the users, logistic department and maintenance department.

- It was found that the major cause of engine failures it was due to wrong type of cylinders used on the 39 200 class diesel locomotive. The 39 200 class uses millmille cylinders not chrome cylinders. They cylinders differ from the material that is been used to make the cylinder.
- According to the questionnaires it was found that most artisans, logistics department
 were not aware of which cylinders supposed to be used on the 39 200 class diesel
 locomotive. The locomotives were newly built in South Africa not all the artisans,
 planners and trade hands were aware of the different cylinders used on the 39 200
 diesel locomotive.
- Thabazimbi depot not having enough resources to perform maintenance on the locomotives to avoid locomotives to be hauled to Koedoespoort (Pretoria) depot.

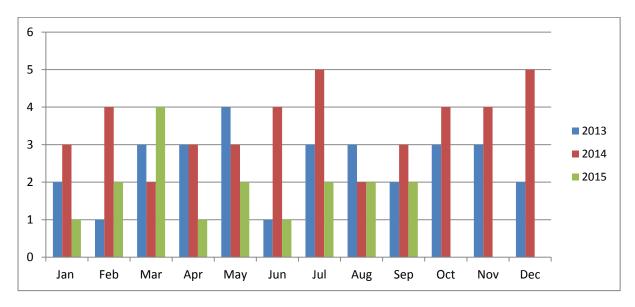
Early returns are locomotives that came back within a week after the scheduled maintenance. Normally it is due to maintenance done by the workers, or things that were impossible to notice during the planned maintenance. Figure 6, shows how many locomotives failed from 2013-2015 each month. It shows high failing rate during a year of 2014.

Shortage of resources and material at Thabazimbi was one of the contributing factors for early returns. The personnel were not able to do all the works due to the time constrain.

Figure 6: Early Returns 2013-2015 (Transnet, 2014)
