Environmental Contamination Threat from the Deposition of Construction and Demolition Waste (CDW)

Emmanuel Emem-Obong Agbenyeku, Edison Muzenda and Innocent Mandla Msibi

Keywords—Construction and Demolition Waste, Effluent, Landfill, Leachate, Percolation

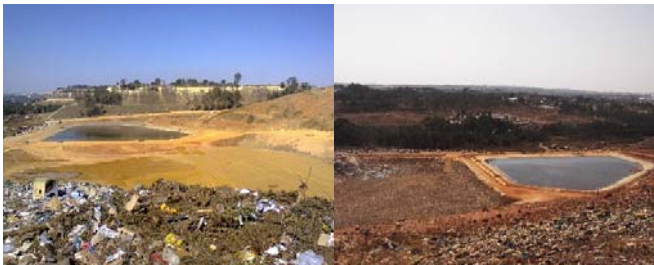
Fig. 1. Sampling site of the CDW containing CCA treated materials used in the study

The CDW containing fragments of wooden materials treated with CCA was collected in Johannesburg, South Africa from a domestic solid waste dump site somewhat far from the leachate pool as shown in Fig. 1. The sampled CDW simulated the waste body used in generating leachate through laboratory experimentations in a fabricated device. The cylindrical small scale device used for the study is about 600 mm long having internal diameter of about 160 mm.

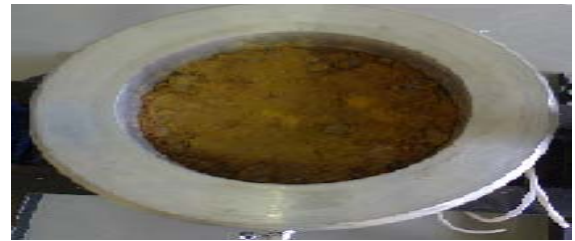
The sizeable CDW with fragmented CCA treated material was fit into the bucket underlying a 20 mm thin layer of lightly rammed clayey soil. The layer of soil prevented a rapid flush out of the influent during the testing process and allowed lasting interaction between the CDW and seeping water to form leachate. The experimental arrangement for the bucket holding the CDW containing fragments of CCA treated materials overlain by the thin layer of soil is shown in Fig. 3.

Fig. 3. Thin soil layer overlying the CDW fitted in the bucket section as used in the study

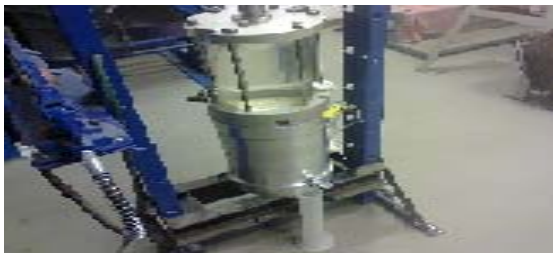
5 shows the complete assemblage studied herein in room temperature with the testing duration lasting up to 10 days. On the formation and flow-out of leachate, a 50 ml cylinder was used to constantly collect the effluent. Only the pH from the general water quality parameters i.e., dissolved oxygen (DO), conductivity, temperature and oxidation-reduction potential (ORP) was reported in the study since other parameters require more standardized measurements and validation. The measurements in the study were done using a Portable Multiflex Beckman Century pH/mV/FT/DO-915A-1202-TM SS-1 Meter Model. The laboratory formed leachate were collected as effluents and stored in plastic containers at a temperature of 2°C to prevent microbial and chemical activities. Samples of the effluents were analyzed by full spectral method according [8] and then compared to the South African standard of drinking water.

Fig. 5. Coupled testing on CDW using de-ionized water as permeant to generate leachate tested in the study

Considering that CDW would continually be dumped in landfills, studying this scenario will contribute to the interest in waste management by offering a closer understanding of the impacts of disposing these waste types on the environment and the implication on human health. To that effect, two main tests were conducted and recorded herein. Test-X represented the experimental scenario simulating CDW with fragmented CCA treated materials in a landfill whereas Test-Y represented the control scenario with selected CDW with no CCA content. Fig.

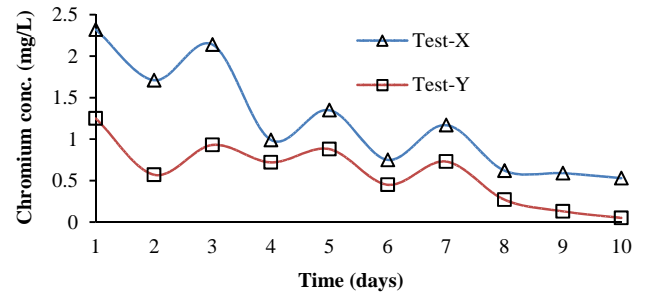
The arsenic and chromium concentrations found in the leachate in Test-X were higher than that of the leachate from Test-Y respectively. The outcomes from the study revealed reasonable similarities with studies by [4]. Nevertheless, it is noted that since the study herein was a fast tracked investigation contrary to studies by other authors conducted in fields over long periods, the represented values may not be likened to real life outcomes.

Fig. 7b. Measured chromium for tests on CDW with and without materials treated with CCA
