# A CASE STUDY OF INDUCED CURRENT UNBALANCE AS A RESULT OF CAPACITOR FAILURE

**Abstract:** Capacitor banks rated 132 kV/ 72 MVAR are installed at the Durban North Substation of Ethekwini municipality to compensate for inductive power losses. The POW or synchronous switching technique is used for on-line switching of these banks, in a bid to minimise high magnitude induced transient voltage and current. In this study, the voltage waveform records and the percentage current unbalance, measured on and six months post commissioning of the capacitor banks are analysed in order to test the effectiveness of POW switching method, when implemented with mechanically linked 3-phase, 3-pole SF<sub>6</sub> circuit breakers. The results obtained indicate that within 6 months of commissioning, capacitive impedance of the banks failed, as result of high magnitude induced transient current and voltage, and the percentage unbalance level observed in the neutral current grew from 2.3% to 5.7%.

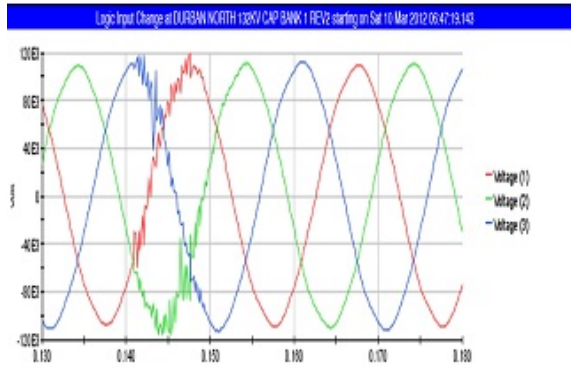
Figure 3: Transient voltage six months after commissioning

The voltage waveforms recorded six months after commissioning show the existence of transients in all the phases upon line switching of capacitor banks. This is shown in figure 3.

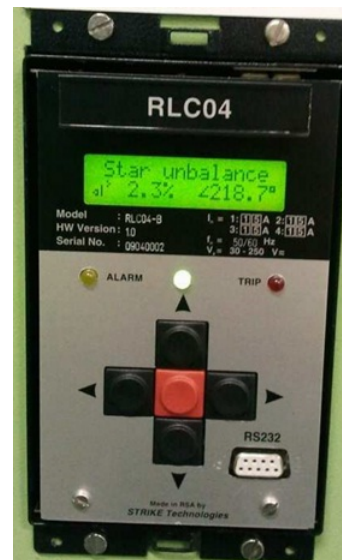
The neutral current measured after commissioning proved to have higher unbalance factor as compared to initial measurement. The results obtained are shown in figures 5 and 6. This relates to the fact that almost no transient voltage and current are induced on commissioning as compared to higher magnitude induced six months post commissioning of the capacitor banks.

Figure 5: Current unbalance level on commissioning

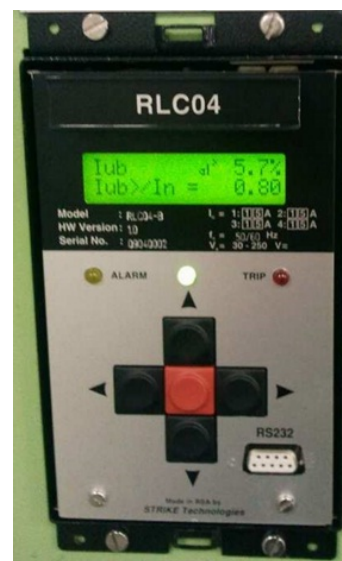
The increase in the level of unbalance in the neutral current is a direct consequence of aggravated change in the impedance of capacitor banks, which are triggered by induced switching transients. This is indeed proven by testing the capacitance of the bank. This testing revealed

Figure 6: Current unbalance level after commissioning

that seven capacitor units of the bank had failed due to resulting high magnitude transient voltage and current. Capacitor units failure occur as a result of increasingly high frequency voltage and current transient. This inrush amount of transient energy has the effect of causing the electrodes of the capacitor unit to short circuit. Since, the transient state lasts only for a few cycles, the resulting steady state overall capacitance and capacitive impedance of the capacitor bank will therefore be compromised. This implies therefore aggravated unequal current and voltage distribution across the phases. The level of unbalance measured in the neutral current in this study, happens to be 5.7% six months post commissioning, against 2.3% on commissioning of the capacitor banks.
