# Experimental analyses to investigate the feasibility and effectiveness in using heat pipe-embedded drills

**Abstract** This paper presents an experimental investigation to verify the feasibility and effectiveness of heat pipe cooling in drilling operations. The basic idea is to insert a heat pipe at the center of the drill tool with the evaporator close to the drill tip and the condenser at the end of the drill. Consequently, the heat generated at the tool–chip interface can be removed by convection heat transfer. Experimental studies were involved in three cases, including solid drill without coolant, solid drill with coolant, and heat pipe drill. Drilling tests were conducted on a CNC machining center with full immersion cutting. The cast iron square block was used as the workpiece, and the high-speed steel was chosen for the drill tool material. Flank wear is considered as the criterion for tool failure, and the wear was measured using a Hisomet II Toolmaker’s microscope. The tests were conducted until the drill was rejected when an average flank wear greater than 0.10 mm was recorded. The results demonstrate that using a heat pipe in the drilling process can effectively perf

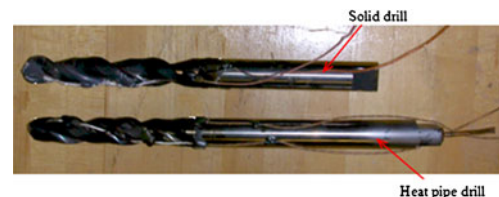
Fig. 4 Solid drill and heat pipe drill

Figure 4 shows the schematics of solid drill and heat pipe drill in the experiments.

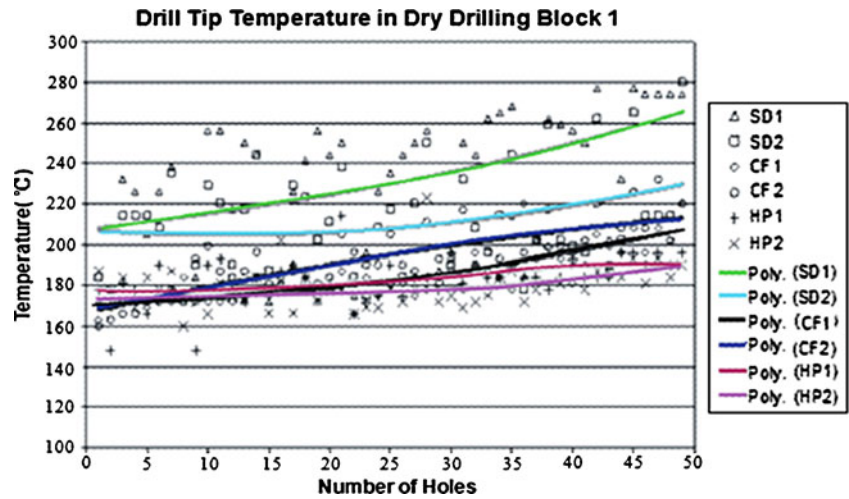
**Fig. 8** Temperature trend versus number of holes, block #1

Figure 8 shows the temperature trends of all the tool tips during drilling the first block. None of the drills failed in

the above operations. However, the tip temperatures under dry drilling condition were higher than those under either cutting fluid supply or the heat pipe supply drilling conditions. Compared with the heat pipe drill-tip temperature, the tip temperatures under cutting fluid supply drilling conditions were also slightly higher, and displayed more of an upward trend.

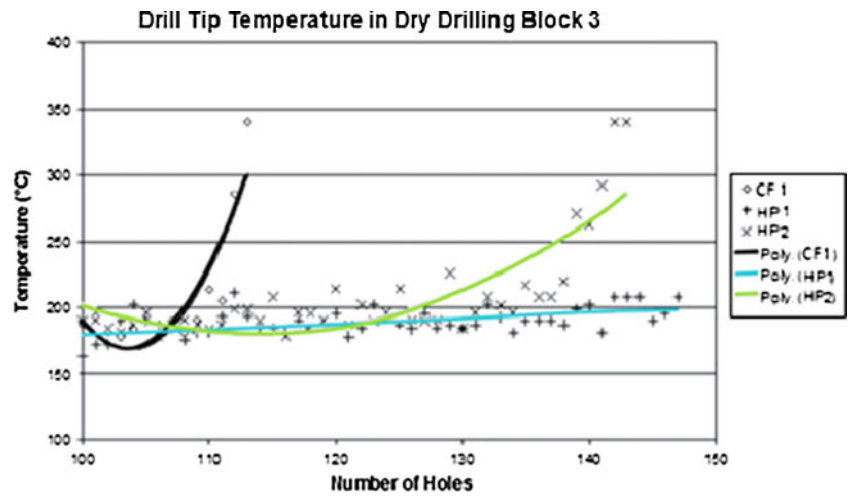
**Fig. 10** Temperature trend versus number of holes, block #3

Figure 10 indicates the tool-tip temperature trends of the remaining non-failed drills during cutting the third block. It could be seen that the drills also failed when the drill-tip temperature reached 340°C. The failed drills displayed a much sharper increase in the temperature trend compared with that in drilling the second block applications. The first solid drill with cutting fluid supply (CF<sub>1</sub>) failed at the 15th (113th overall) hole, the second heat pipe drill (HP<sub>2</sub>) failed at the 45th (143rd overall) hole, but the first heat pipe drill (HP<sub>1</sub>) survived with a slightly higher temperature in comparison with those in drilling the first two blocks operations.

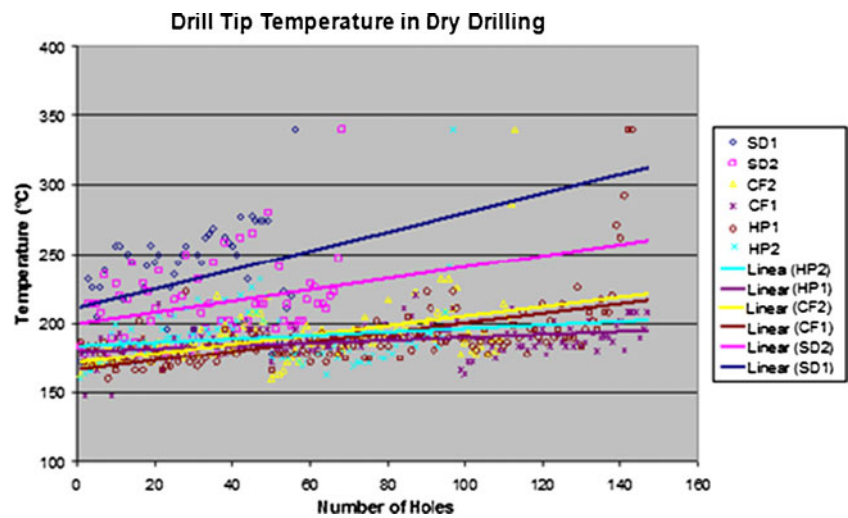
**Fig. 11** Temperature trend versus time, all blocks

Figure 11 presents the temperature trends of the six drills over the entire drilling time. It could be seen that the drill-tip temperature at failure was recorded as 340°C, and the temperatures increased sharply just before the drills failed. The experimental results show that experiments under heat pipe supply drilling condition resulted in approximately 120 min in tool life, which gives an improvement of tool

It is affirmed from Figs. 8, 9, 10, and 11 that using a heat pipe inside the drill could significantly reduce temperature in the cutting zone compared with solid drill and solid drill with cutting fluid supplied. Therefore, tool life is significantly influenced by heat pipe, which is responsible for increasing the tool life. This is because most of the heat generated on the drill tip could be removed effectively and quickly from heat pipe by convection heat transfer.

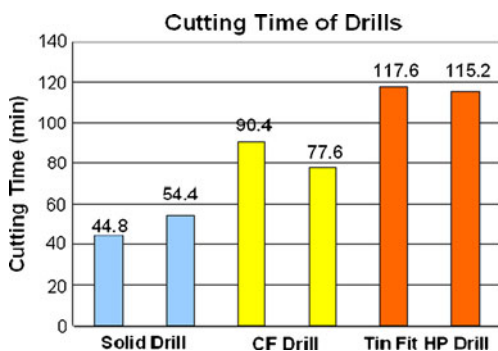
**Fig. 16** Comparison of tool lives under various drilling conditions

Figure 16 presents the tool life as a function of the cutting time. The solid drills resulted in 44.8 and 54.4 min (or 56 and 68 holes) in tool life, the drills with cutting fluid supplied had tool lives of 90.4 and 77.6 min (or 113 and 97 holes), and the heat pipe drills 117.6 and 115.2 min (or 147 and 143 holes). The experiment with heat pipe supply gives an improvement of tool life by 2.2 and 1.6 times under dry drilling and cutting fluid supply conditions,

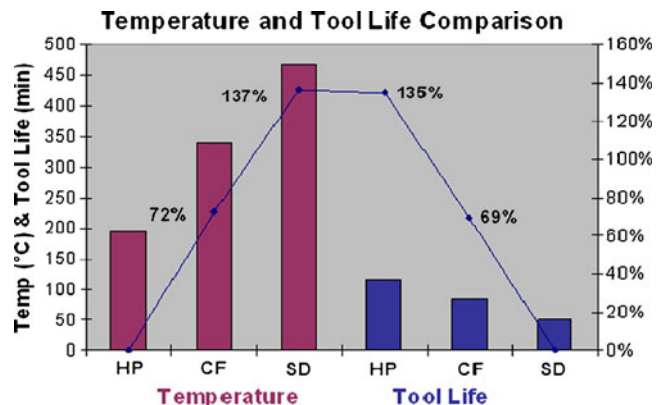
**Fig. 17** Comparisons of tool lives and temperatures drill under various drilling conditions

respectively (see Fig. 17). Reducing the drill temperature was found to be critical in extending the drill tool life and, hence, most appreciable improvement of tool life takes place with heat pipe supply. This is basically because heat pipe can sufficiently help to prevent premature tool failure due to high drill temperature in the severe drilling operations.
