## Power transformer failure management on the Eskom distribution network in Limpopo

MM Sako\*, A Wessels\*\* and JHC Pretorius\*\*\*

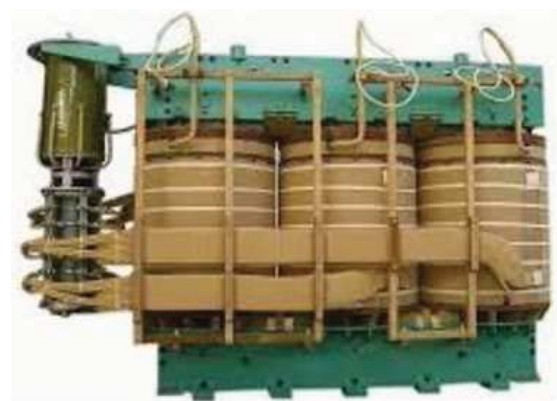
The following figure below shows the active part of a power transformer, consisting of the windings covered in cellulose insulation.

Figure 3: Active part of a power transformer [2]
