Impacts of Landfill Disposal of Construction and Demolition Waste (CDW)

Agbenyeku E. Emmanuel¹, Aigbavboa O. Clinton¹, Kukoyi T. Oladayo¹

¹ Faculty of Engineering and the Built Environment, University of Johannesburg, Johannesburg, South Africa, 17011

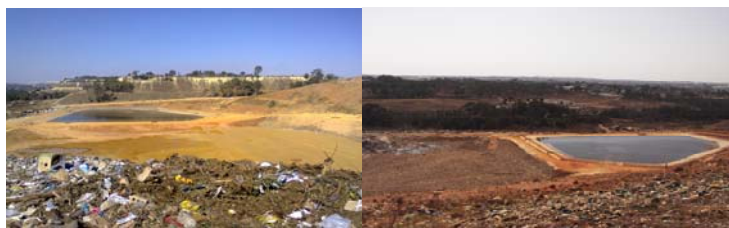
Figure 1 Sampling area for the CDW containing CCA treated materials used in the study

The CDW containing fragments of wooden materials treated with CCA was collected in Johannesburg, South Africa from a domestic solid waste dump site somewhat far from the leachate pool as shown in Figure 1. The sampled CDW simulated the waste body used in generating leachate through laboratory experimentations in a fabricated device. The cylindrical small scale device used for the study is about 600 mm long having internal diameter of about 160 mm.

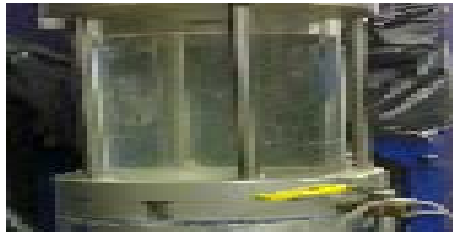
Figure 4 Upper component of the device with de-ionized water in the reservoir as used in the study

ii. the upper component joined to the bucket section called the reservoir; held de-ionized water as influent slowing draining into the waste body (in the bucket section) till leachate was generated, collected as effluent and the concentration of the collected effluent was tested periodically to examine the changes in the targeted toxic contents. The upper component of the assembled device as used in the study is seen in Figure 4.

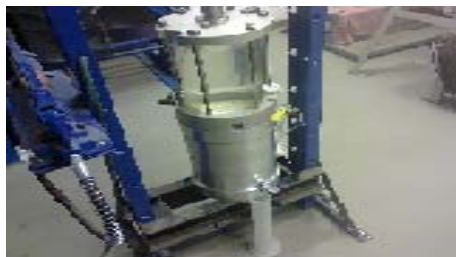
Figure 5 Assemblage testing on CDW using de-ionized water as permeant to generate leachate tested in the study

Considering that CDW would continually be dumped in landfills, studying this scenario will contribute to the interest in waste management by offering a closer understanding of the impacts of disposing these waste types on the environment and the implication on human health. To that effect, two main tests were conducted and recorded herein. Test-X represented the experimental scenario simulating CDW with fragmented CCA treated materials in a landfill whereas Test-Y represented the control scenario with selected CDW with no CCA content. Figure 5 shows the complete assemblage studied herein in room temperature with the testing duration lasting up to 10 days. On the formation and flow-out of leachate, a 50 ml cylinder was used to constantly collect the effluent. Only the pH from the general water quality parameters i.e., dissolved oxygen (DO), conductivity, temperature and oxidation-reduction potential (ORP) was reported in the study since other parameters require more standardized measurements and validation. The measurements in the study were done using a Portable Multi-flex Beckman Century pH/mV/FT/DO-915A-1202-TM SS-1 Meter Model. The laboratory formed leachate were collected as effluents and stored in plastic containers at a temperature of 2°C to prevent microbial and chemical activities. Samples of the effluents were analyzed by full spectral method according [8] and then compared to the South African standard of drinking water.
