Potential Risks of CCA-Treated Wood Destined to Landfills

Emmanuel Emem-Obong Agbenyeku, Edison Muzenda and Innocent Mandla Msibi

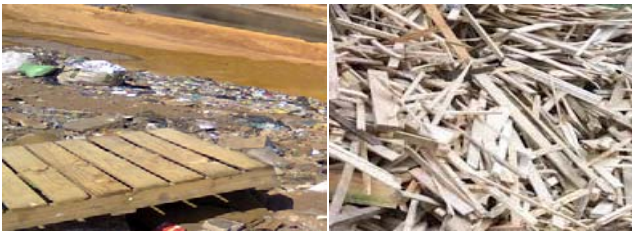
The CCA-treated wood was sampled in arm length and broken pieces from a disposal site slightly distant from heaps of other domestic solid waste in Johannesburg, South Africa as seen in Fig. 1a and b. This was used as the waste body since the study herein sought to generate leachate from the deposition of CCA-treated wood by using a laboratory bespoke column device to simulate a monofill. A small scale bespoke device about 600mm long with internal diameter of about 160mm was used in the study.

(a) Landfill area (b) CCA-treated wood waste
Fig. 1. (a) and (b) Sampling site of CCA-treated wood waste

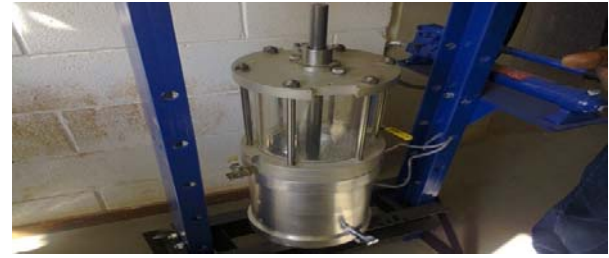
Fig. 2. (a) and (b) Bespoke test device

A pictorial and schematic view of the laboratory bespoke device is shown in Fig. 2a and b respectively. For the purpose of this study, the device was coupled to comprise of two sections:

- 1) the bottom part called the bucket section; which contained the CCA-treated wood to a height of 230mm, simulated the waste in a monofill. The sampled CCA-treated wood waste was chopped into smaller particle sizes so as to fit into the small scale bespoke apparatus. Selected gravel was

laid as drainage path in the bucket section and a wet geotextile was placed over it to prevent clogging of the outlet by moving fines which served as the filter bed in the system.

(a) Pictorial view

(b) Schematic view

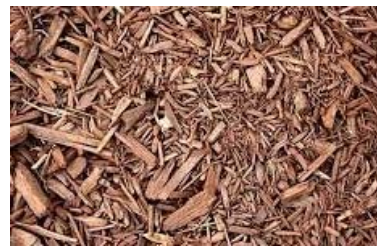
While Fig. 4 and Fig. 5a and b shows the chopped CCA-treated wood and the experimental arrangement for the bucket containing the CCA-treated wood respectively.

Fig. 4. CCA-treated wood chopped into smaller pieces for percolation tests

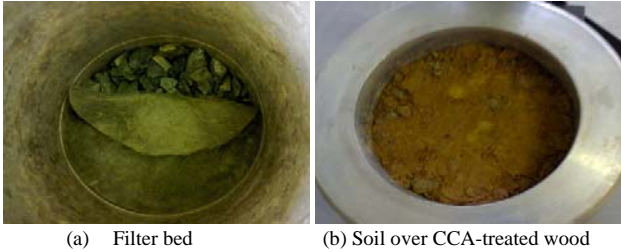
Fig. 5. (a) and (b) Wet geotextile placed over selected gravel and lightly compacted clayey soil over chopped CCA-treated wood in the bucket section

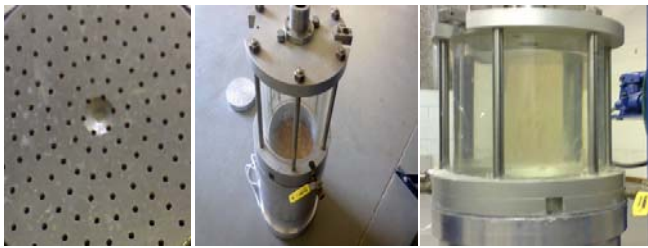
2) the upper part above the bucket section called the reservoir; contained de-ionized water as influent which flowed through a perforated plate into the bucket section (waste body) simulating low intensity rain droplets slowly saturating the waste body till leachate was formed and the concentration of the collected effluent was tested at intervals to monitor the concentration levels of the targeted chemical ions. The system was coupled firmly using O-rings, gasket corks and silicon sealants to ensure a leakage free assembly. The reservoir held a water head of 250mm which was manually topped as the water level dropped since a mechanism for retaining constant head was not designed for in the device. Fig. 6a and b show the upper section of assembled device for the experimental study carried out.

Fig. 6. (a) and (b) Perforated plate through which de-ionized water as influent in the reservoir section flowed simulating low intensity rain droplets

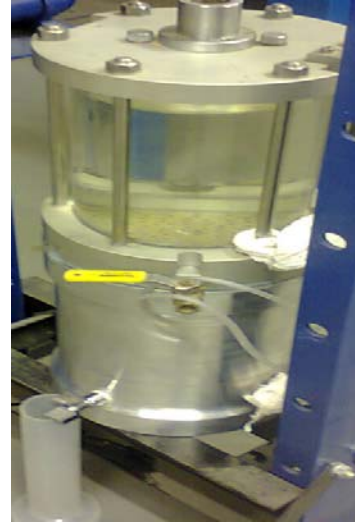
Fig. 7. Percolation test under study using de-ionized water as permeant for CCA-treated wood with the effluent collected and tested at intervals to track the concentration levels of the targeted chemical ions of concern

In this study, the choice of CCA-treated wood monofill offers the worst-case disposal scenario in unlined sites considering that the disposal of chemical treated wood will in a long time to come be continually dumped. This case will also aid a clearer understanding on the chemical ions generated thereof without intrusion from contaminant species of other sources. As such, outside other confirmatory percolation tests conducted in the study, two main tests were considered and recorded. Test-A represented the experimental case for simulated CCA-treated wood in a monofill while Test-B represented the control case with untreated wood. The fully assembled percolation test setup studied herein is shown in Fig. 7. The tests were conducted in room temperature with respective tests lasting up to 15 days. On the formation and breakthrough of leachate, a 50ml cylinder was used to constantly collect the effluent. Although, general water quality parameters i.e., pH, dissolved oxygen (DO), conductivity, temperature and oxidation-reduction potential (ORP) were measured in the study using a Portable Multi-flex Beckman Century pH/mV/FT/DO-915A-1202-TM SS-1 Meter Model, however, only pH was discussed as other parameters require validation. Collected leachate were put in plastic containers

and stored in a cooling chamber at 2°C to prevent any form of chemical or biological activities. The effluent samples were then analyzed by full spectral method and were compared to South African standard of drinking water in conformance with [10].
