Experimental Analysis of Damage Development in Carbon Fiber Reinforced Composites under Cyclic Loading

M.E. Hluyo¹, D.M. Madyira¹, N. Janse van Rensburg¹

¹Department of Mechanical Engineering Science, University of Johannesburg, South Africa

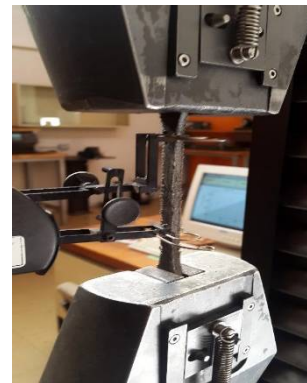
In order to determine the stress level to be used in fatigue, it was important to conduct static tensile tests. Displacement control tensile tests were conducted on the Instron 1195 machine driven by Bluehill software 2 (Figure 1 (a)). The machine is equipped with a standard load cell of 100kN capacity and a crosshead displacement measuring device. The tests were conducted according to ASTM D3039, which recommends that failure occurs within 10 mins, hence a stroke rate of 2mm/min was chosen [9]. The tensile test specimen setup is as shown in figure 1 (a).

Figure 1: (a) Tensile test setup (b) Three-Point Flexural test schematic

Three point flexural tests were conducted using the same Instron 1195 machine used during the static tensile tests. The specimen geometry is the same as the specimen geometry used for fatigue testing. The tests were again conducted at a stroke rate of 2mm/min. However, this time a 10kN load cell was used in order to improve accuracy of the applied load. The schematic for flexural testing is as shown in Figure 1(b).
