Environmental Contamination Threat from the Deposition of Construction and Demolition Waste (CDW)

Emmanuel Emem-Obong Agbenyeku, Edison Muzenda and Innocent Mandla Msibi

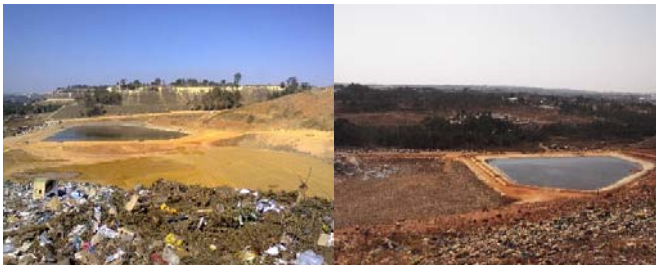
The CDW containing fragments of wooden materials treated with CCA was collected in Johannesburg, South Africa from a domestic solid waste dump site somewhat far from the leachate pool as shown in Fig. 1. The sampled CDW simulated the waste body used in generating leachate through laboratory experimentations in a fabricated device. The cylindrical small scale device used for the study is about 600 mm long having internal diameter of about 160 mm.

Fig. 1. Sampling site of the CDW containing CCA treated materials used in the study

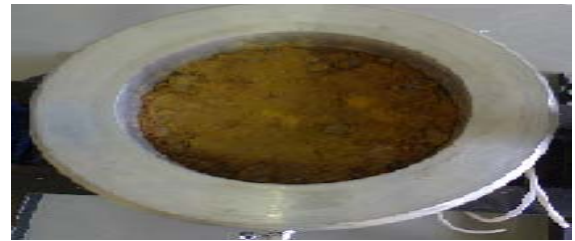
The sizeable CDW with fragmented CCA treated material was fit into the bucket underlying a 20 mm thin layer of lightly rammed clayey soil. The layer of soil prevented a rapid flush out of the influent during the testing process and allowed lasting interaction between the CDW and seeping water to form leachate. The experimental arrangement for the bucket holding the CDW containing fragments of CCA treated materials overlain by the thin layer of soil is shown in Fig. 3.

Fig. 3. Thin soil layer overlying the CDW fitted in the bucket section as used in the study

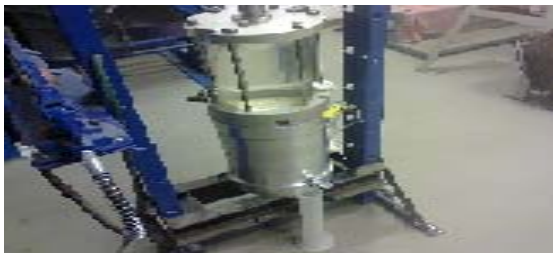
5 shows the complete assemblage studied herein in room temperature with the testing duration lasting up to 10 days. On the formation and flow-out of leachate, a 50 ml cylinder was used to constantly collect the effluent. Only the pH from the general water quality parameters i.e., dissolved oxygen (DO), conductivity, temperature and oxidation-reduction potential (ORP) was reported in the study since other parameters require more standardized measurements and validation. The measurements in the study were done using a Portable Multiflex Beckman Century pH/mV/FT/DO-915A-1202-TM SS-1 Meter Model. The laboratory formed leachate were collected as effluents and stored in plastic containers at a temperature of 2°C to prevent microbial and chemical activities. Samples of the effluents were analyzed by full spectral method according [8] and then compared to the South African standard of drinking water.

Fig. 5. Coupled testing on CDW using de-ionized water as permeant to generate leachate tested in the study

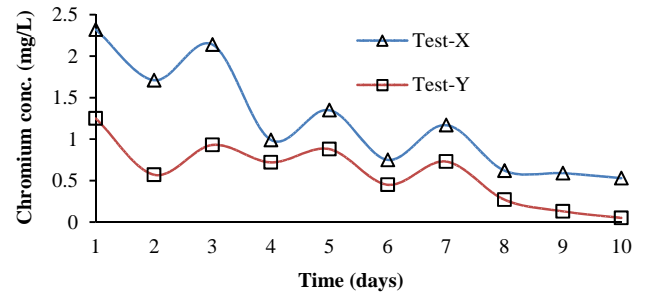
The arsenic and chromium concentrations found in the leachate in Test-X were higher than that of the leachate from Test-Y respectively. The outcomes from the study revealed reasonable similarities with studies by [4]. Nevertheless, it is noted that since the study herein was a fast tracked investigation contrary to studies by other authors conducted in fields over long periods, the represented values may not be likened to real life outcomes.

Fig. 7b. Measured chromium for tests on CDW with and without materials treated with CCA
